Case Studies III: Rehabilitation of the Yarqon River, a Mediterranean Climate Polluted Stream Ecosystem, and the Reintroduction of the Yarqon Bleak - an Israeli Endemic Critically Endangered Freshwater Cyprinid Fish

Yonathan Raz
Yarqon River Authority

**Rehabilitation of the Yarqon river, a
Mediterranean Climate polluted stream
Ecosystem, and the reintroduction of the
Yarqon bleak- an Israeli endemic critically
endangered freshwater cyprinid fish**

**Yonathan raz
ISRAEL**

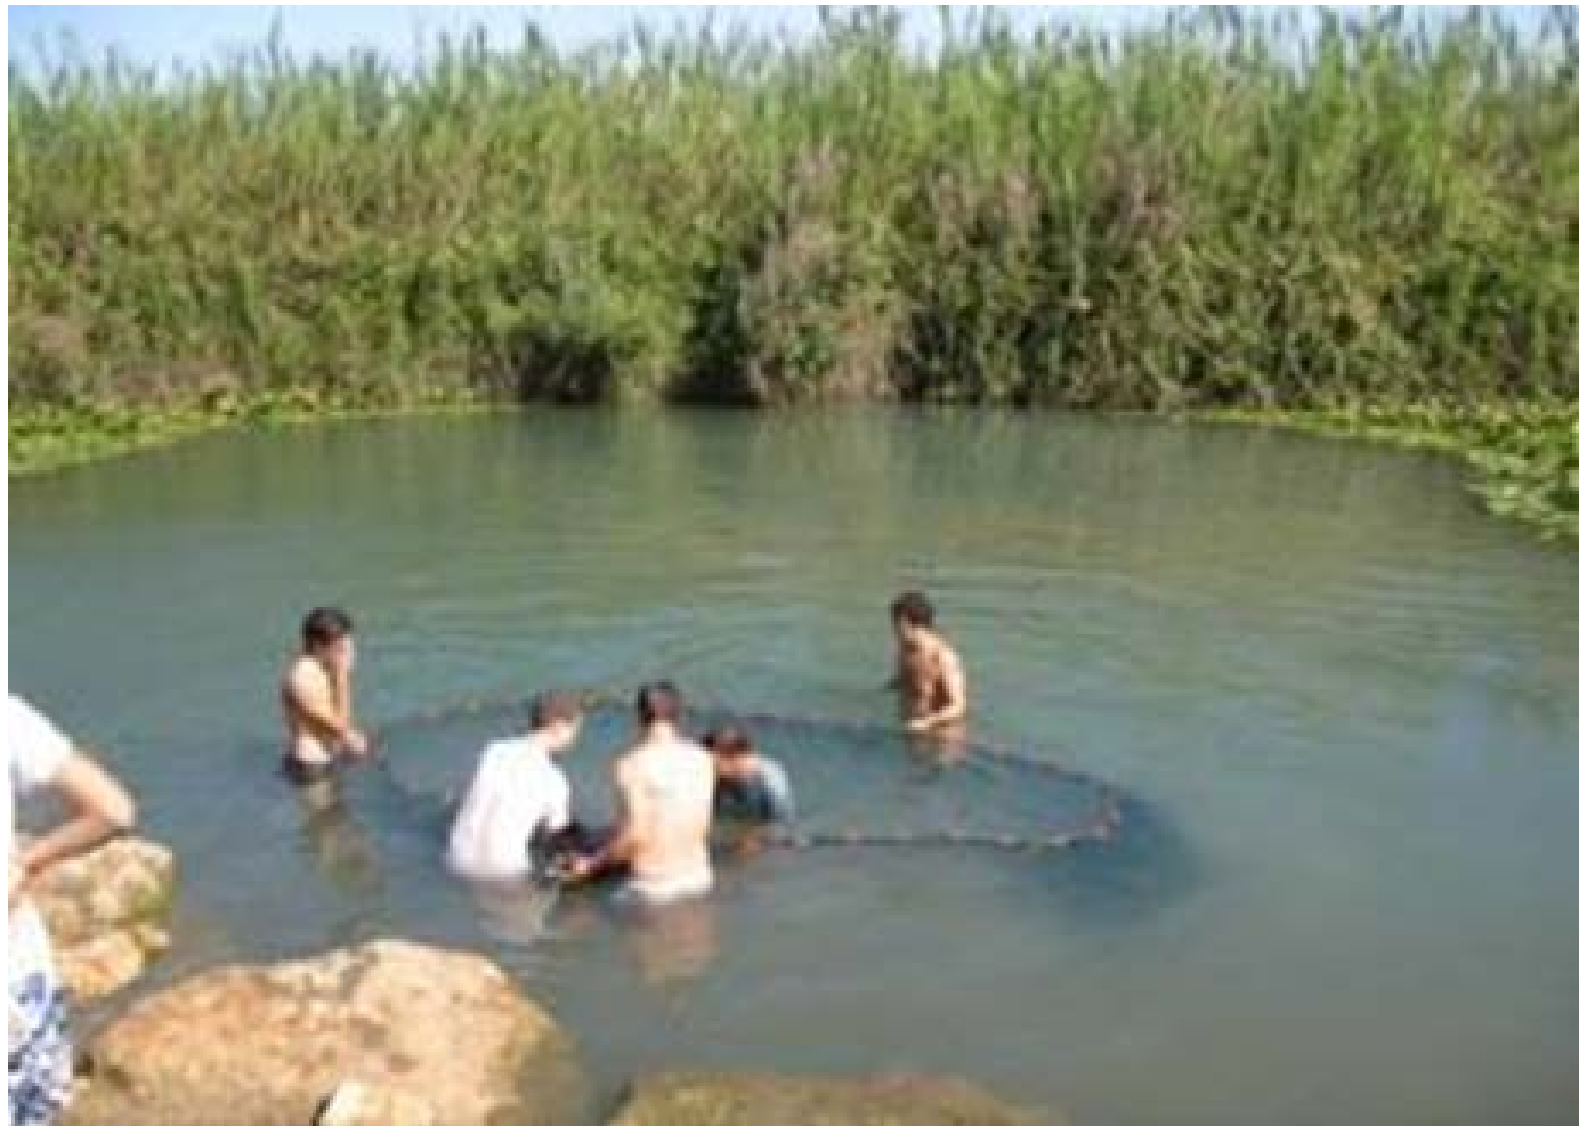
distribution of fish species at the headwaters/spring, 2014 survey

- *Acanthobrama telavivensis*
- *Tilapia zilli*
- *Cyprinus carpio*
- *Gambusia affinis*
- *Clarias gariepinus*

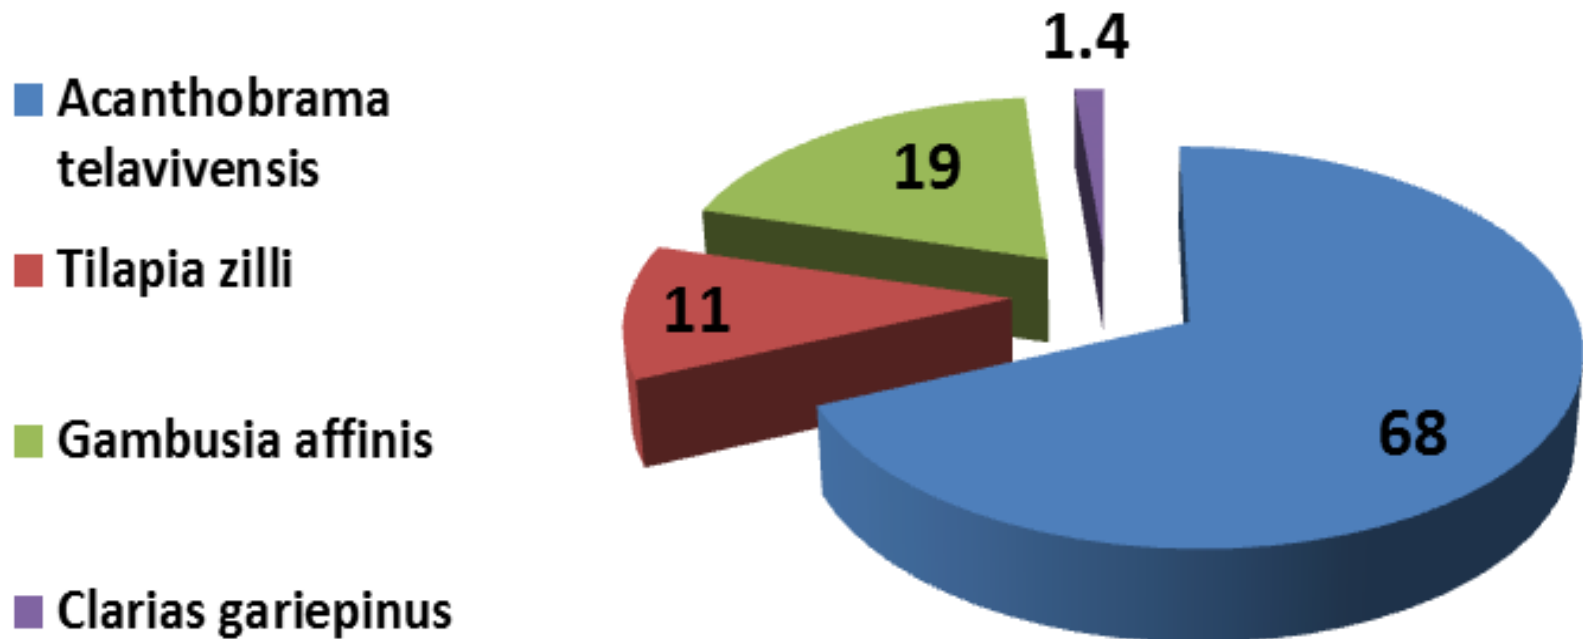
distribution of fish species at lower part of upper reach, 2014 survey
